# Restoration Corner

Disaster Update-Governor's Mansion Update

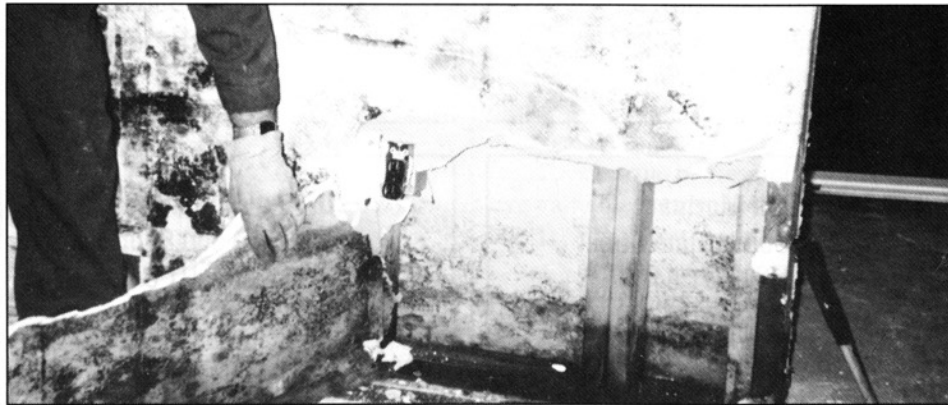
On December 15, 1993, a short from an extension cord caught the Christmas tree on fire in the Governor's Mansion. The fire quickly spread up the spiral staircase ravaging everything in its path up to and including the gold dome on the third floor.

The fire not only caused structural damage to the front entry, main stairway and dome, but also contaminated the entire structure with soot and smoke. To thoroughly clean and decontaminate the home, more than 80% of all plaster had to be removed from the inside walls, expos-

UDK was called to perform two phases in the restoration process, the first being content cleaning and deodorization and the second dealing with the decontamination, cleaning and deodorization of the structure.

To remove the soot from ornate wood carvings and other delicate surfaces, UDK brought in a secret weapon—a Sponge-Jet Blaster. The sponge-blaster shoots small particles of highly absorbent sponge material onto the contaminated surface. The velocity of the sponge impacting the surface causes the soot contaminants to transfer from the surface onto the sponge. Air pressure can also be regulated for aggressive or sensitive cleaning. Different types of sponge material can be used depending on the surface texture and the results desired.
